Lasting natural sheen

Tariq Bashir presents a recent case study where he created a natural smile with little preparation.

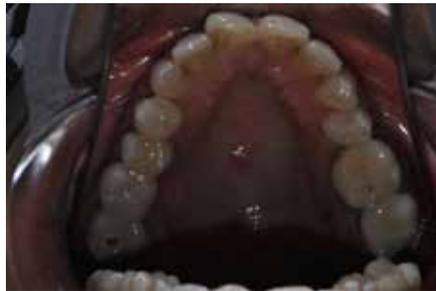
Fig 1: A 45 year old female was concerned with the appearance of her upper anterior teeth, which were butterflyed and worn on the mesio-incisal surfaces.

A 45 year old female was concerned with the appearance of her upper anterior teeth, which were butterflyed and worn on the mesio-incisal surfaces (fig 1). Initially, the patient enquired about veneers and crowns. However, she was not suitable for this very invasive treatment option, as the misalignment of the central incisors was so severe. Preparation would have been extremely invasive and could affect the vitality of the teeth. She elected to have short term orthodontics and direct composite restorations.

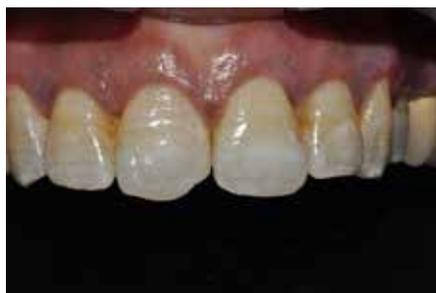
Fig 2: Once the orthodontic treatment was completed, the patient asked for the missing tooth structure to be restored.

The Invisalign system was used to align the central teeth, which took 16 months to accomplish. The patient had both upper and lower alignment to obtain the best result. Heraeus Kulzer Venus Diamond composite was used to create the attachments. Once the orthodontic treatment was completed, the patient asked for the missing tooth structure to be restored (fig 2).

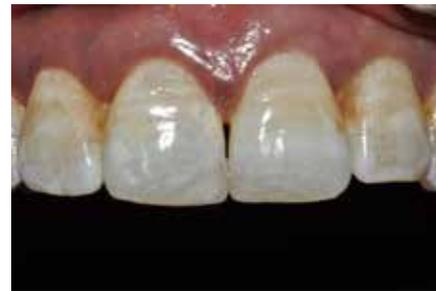
Fig 3: The final natural sheen was achieved using a fine goat hair wheel with the aluminium oxide paste.

The final natural sheen was achieved using a fine goat hair wheel with the aluminium oxide paste (fig 3).

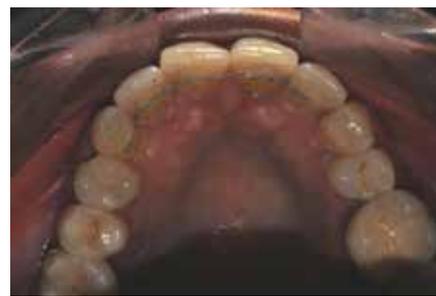
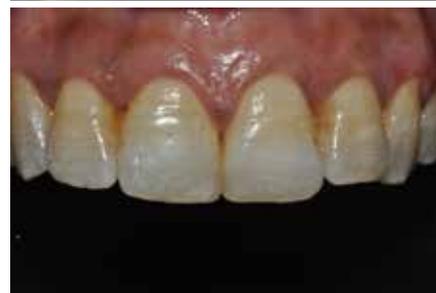
Figs 4a and b: The patient attended recently for her six month examination. Although the retainer needed repair, no further adjustments or polishing were required to the restorations.

The patient was extremely pleased with her new smile, which has given her more confidence. Very minimal preparation was carried out to restore these central incisors. The patient attended recently for her six month examination (figs 4a and b). Although the retainer needed repair, no further adjustments or polishing were required to the restorations.
